Manhole Inspection Summary

Manhole # S39U1_021MH

Insp Date: **11/15/07 10:46 AM**

Location Address: **328 Maude St** Cross Street: **4th & Horton Alley**

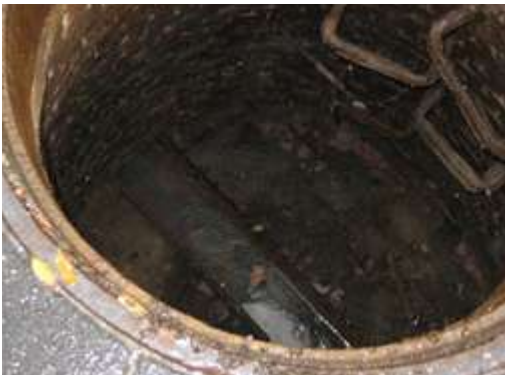
Defect 2

Debris

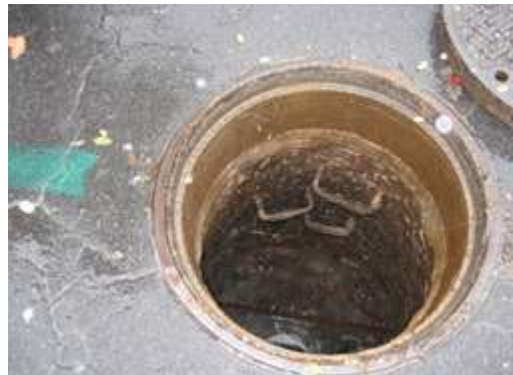
Defect 1

Steps Count: **4** Missing: **0** ☒ **Corroded**

Steps Corroded

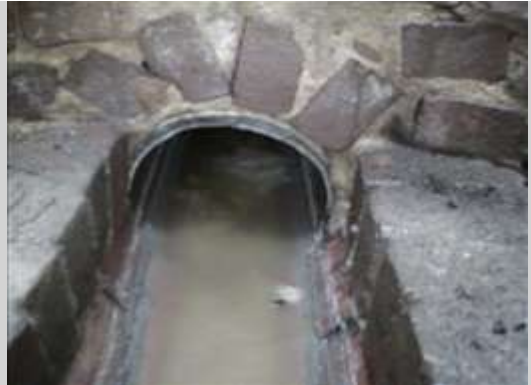
12 O'Clock Outflow

8 in. Circular Gravity Sewer
Pipe Out @ 12 O'Clock

Pipe Height: **9.6** (in.) Rod and Bar (Angled)
Pipe Material: **Clay** ☐ Pipe Lined
Invert Depth: **8.89** (ft.) Flow Characteristics: **Slow**
Deposits: ☐ None ☐ Mud ☐ Sludge ☒ **Debris** ☐ Grease
Silt Depth: **1** (in.) Deposits Extent: **Medium**
Infiltration: **None** Pipe Seal Cond: **Sound**

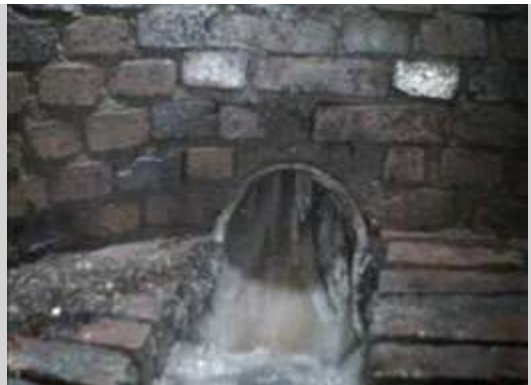
3 O'Clock Inflow

8 in. Circular Gravity Sewer
Pipe In @ 3 O'Clock

Pipe Height: **7.2** (in.) Rod and Bar (Angled)
Pipe Material: **Clay** ☐ Pipe Lined
Invert Depth: **8.81** (ft.) Flow Characteristics: **Turbulent**
Deposits: ☐ None ☐ Mud ☐ Sludge ☒ **Debris** ☐ Grease
Silt Depth: **1** (in.) Deposits Extent: **Heavy**
Infiltration: **None** Pipe Seal Cond: **Sound**

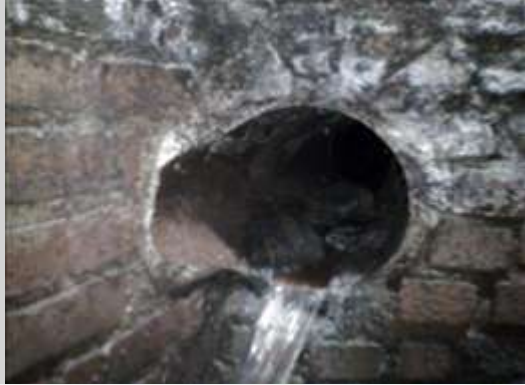
6 O'Clock Inflow

8 in. Circular Gravity Sewer
Pipe In @ 6 O'Clock

Deposits: ☐ None ☐ Mud ☐ Sludge ☒ **Debris** ☐ Grease

Silt Depth: **1** (in.) Deposits Extent: **Medium**
